Lake Carmel Dam (NYS DEC ID No: 231-0867)

Town of Kent Workshop

ENGINEERING REPORT (PRE-DESIGN STUDY)

Town of Kent, Putnam County, New York

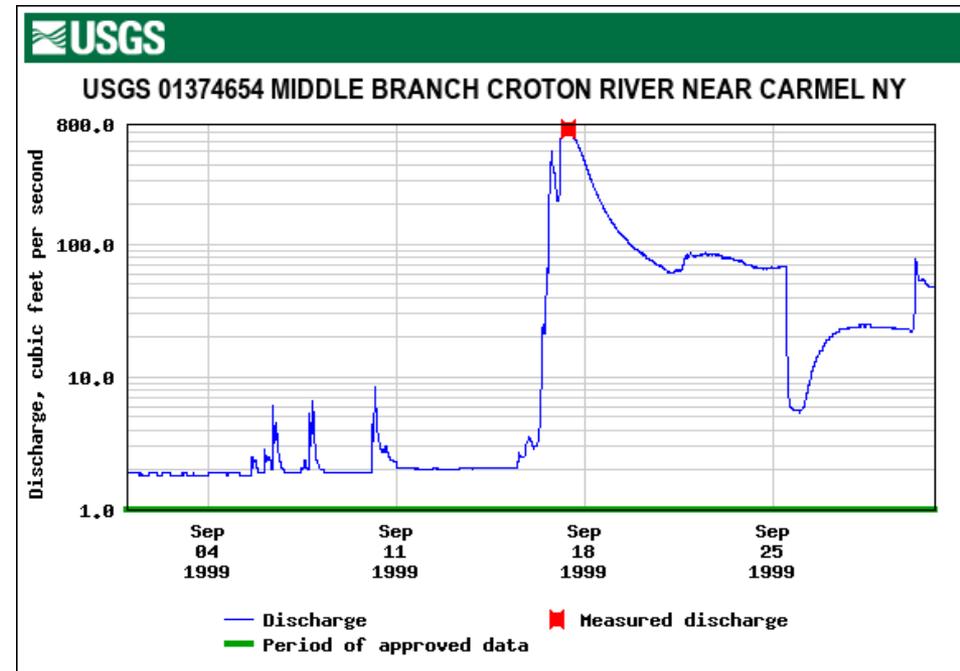
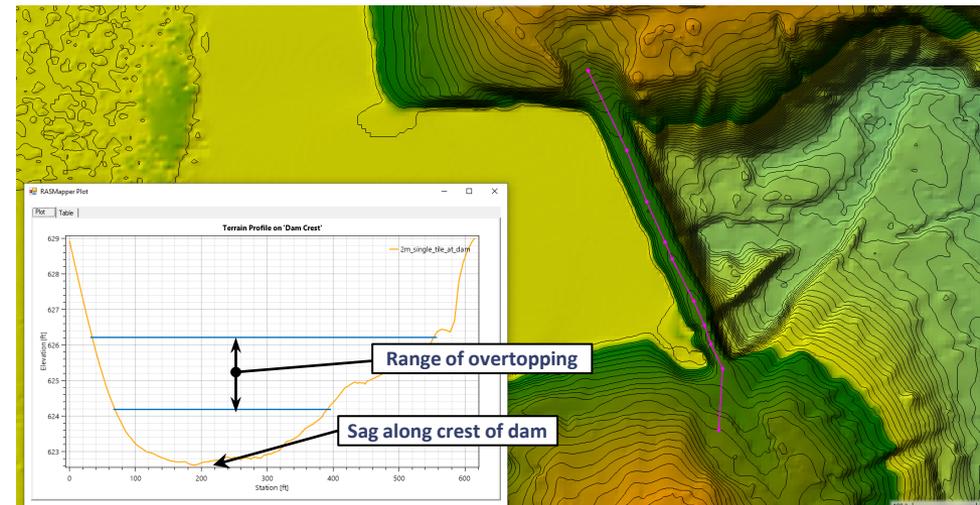
Hydrologic and Hydraulic (H&H) Parameters

Existing spillway has insufficient capacity to safely pass the required Spillway Design Flood (SDF)

- Stormwater inflow is greater than spillway capacity
- Insufficient capacity to safely convey the 50% PMF SDF (req'd)
- Water rises into bridge structure and overtops embankment dam by several feet
- Spillway is significantly deteriorated and at risk of erosional breach

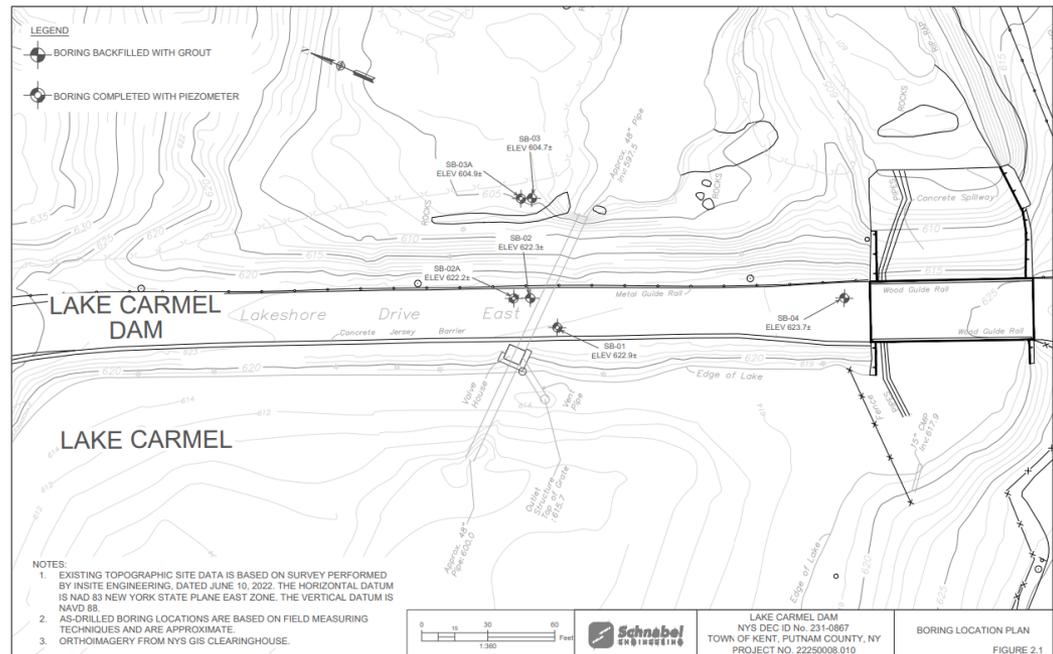
Subsurface Explorations (Soil Borings)

Conducted geotechnical subsurface explorations at embankment dam and spillway bridge abutment.

- Completed four borings
- Obtained soil samples for geotechnical laboratory testing
- Identified bottom of embankment and explored the foundation
- Installed instrumentation (piezometers)
- Measured seepage line (piezometric surface) through embankment dam

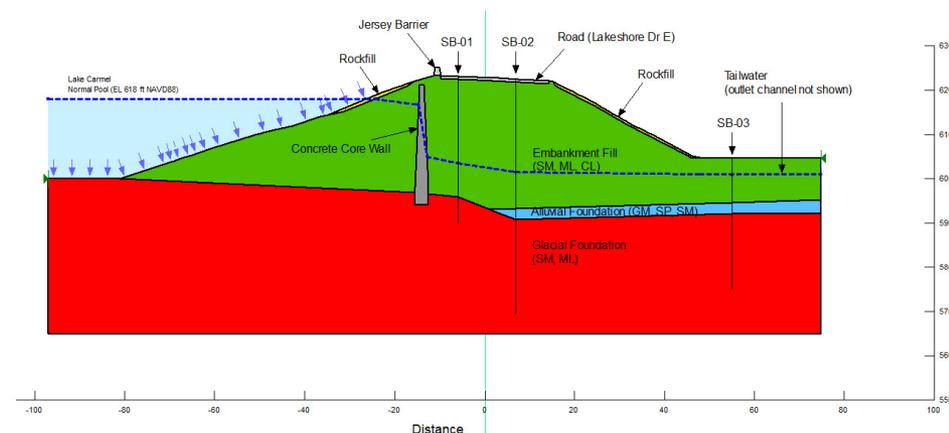
Figure 3.2: Analyzed Geometry of Selected Cross-Section (looking north)

- Embankment geometry (cross-section) obtained from recent Insite topographic survey
- Evaluated standard loading cases:
 - Normal Pool (Steady-State Seepage)
 - Max. Surcharge Pool (Steady-State Seepage)
 - Rapid Drawdown (Normal Pool)
 - Rapid Drawdown (Maximum Pool)
 - Seismic Yield Acceleration

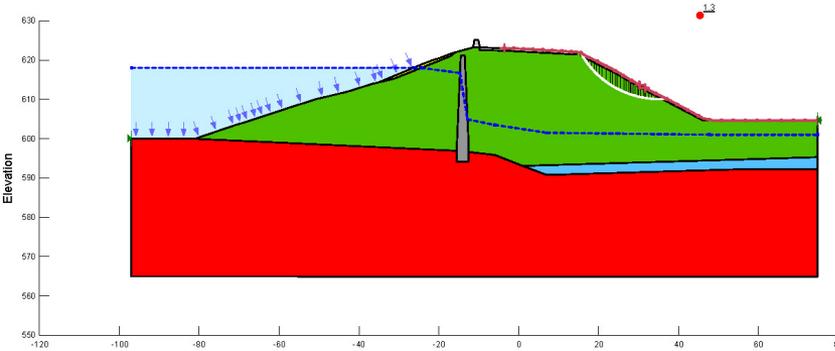
Lake Carmel Dam
 (1b) D/S Slope - Normal Pool (EL 618)
 August 2022
 Created By: Zachary King, EIT
 Checked By: Matthew Palmer

Factor of Safety (FS) for Standard static slope stability Cases 1b and 2:

- Case 1b - Normal pool, FS = 1.3
- Case 2 - Maximum pool, FS = 1.1
- **Required FS = 1.5**

Topography based on physical survey performed by Insite Engineering on June 10, 2022. Internal geometry based on 2022 subsurface explorations performed by Schnabel Engineering and historical 1930s design drawings.

Color	Name	Unit Weight (pcf)	Effective Cohesion (psf)	Effective Friction Angle (°)
Green	(1) Embankment Material	120	0	31
Blue	(2) Alluvial Foundation	125	0	35
Red	(3) Glacial Foundation	130	0	34
Yellow	(4) Rockfill	140	0	40
Grey	(5) Concrete Core Wall	150	5,000	0
Light Grey	(6) Road	150	2,500	0

- FS presented for potential range in soil strengths
- FS < Required for several loading cases
- FS for existing steep d/s slope geometry is very sensitive to soil strength

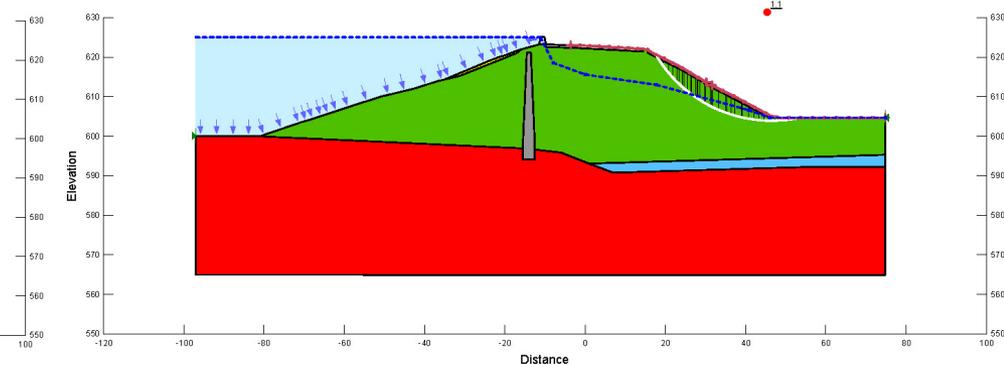
Lake Carmel Dam
 (2) D/S Slope - Max Pool (EL 625)
 August 2022
 Created By: Zachary King, EIT
 Checked By: Matthew Palmer

Topography based on physical survey performed by Insite Engineering on June 10, 2022. Internal geometry based on 2022 subsurface explorations performed by Schnabel Engineering and historical 1930s design drawings.

Color	Name	Unit Weight (pcf)	Effective Cohesion (psf)	Effective Friction Angle (°)
Green	(1) Embankment Material	120	0	31
Blue	(2) Alluvial Foundation	125	0	35
Red	(3) Glacial Foundation	130	0	34
Yellow	(4) Rockfill	140	0	40
Grey	(5) Concrete Core Wall	150	5,000	0
Light Grey	(6) Road	150	2,500	0

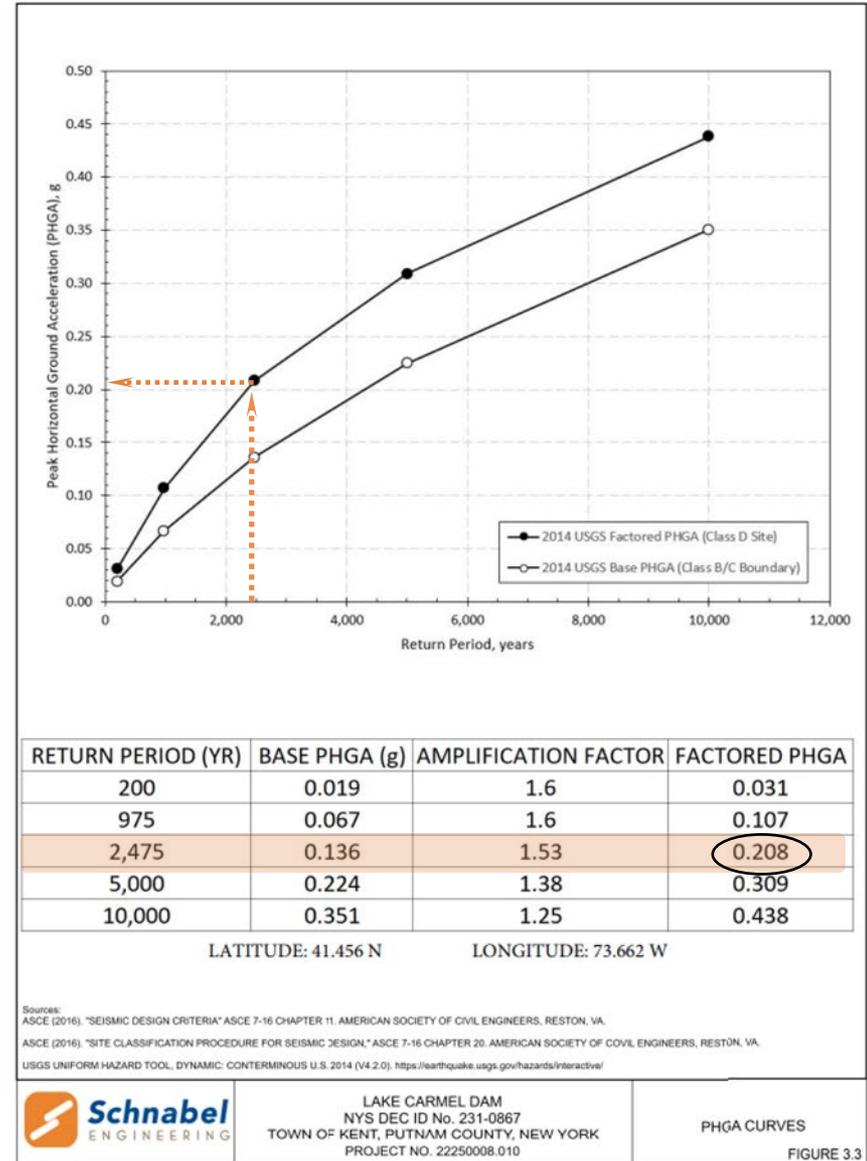
Dams must be stable against seismic motion (horizontal yield acceleration).

- Design Earthquake is 2,475 yr. event
- Subsurface explorations help define Site Class based on soil type(s)
- Lake Carmel Dam is founded on Site Class D foundation soils
- Horizontal Yield Acceleration = .21g for Site Class D

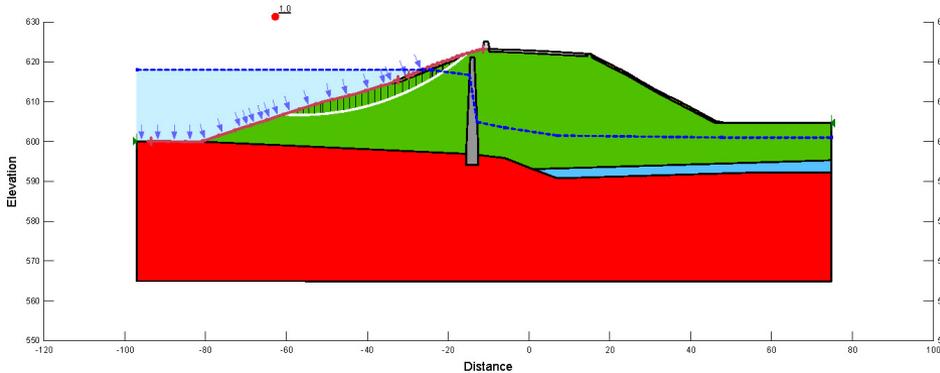
Lake Carmel Dam
 (4a) U/S Slope - Seismic Yield (EL 618)
 August 2022
 Created By: Zachary King, EIT
 Checked By: Matthew Palmer

- Case 4A - Upstream $Y_H = 0.15g$
- Case 4B – Downstream $Y_H = 0.16g$
- **Less than required $Y_H = 0.21g$**

Horz Seismic Coef.: 0.148

Color	Name	Unit Weight (pcf)	Effective Cohesion (psf)	Effective Friction Angle (°)	Cohesion R (psf)	Phi R (°)
Green	(1) Embankment Material	120	0	31	200	17
Blue	(2) Alluvial Foundation	125	0	35	0	0
Red	(3) Glacial Foundation	130	0	34	200	18
Yellow	(4) Rockfill	140	0	40	0	0
Grey	(5) Concrete Core Wall	150	5,000	0	0	0
Light Grey	(6) Road	150	2,500	0	0	0

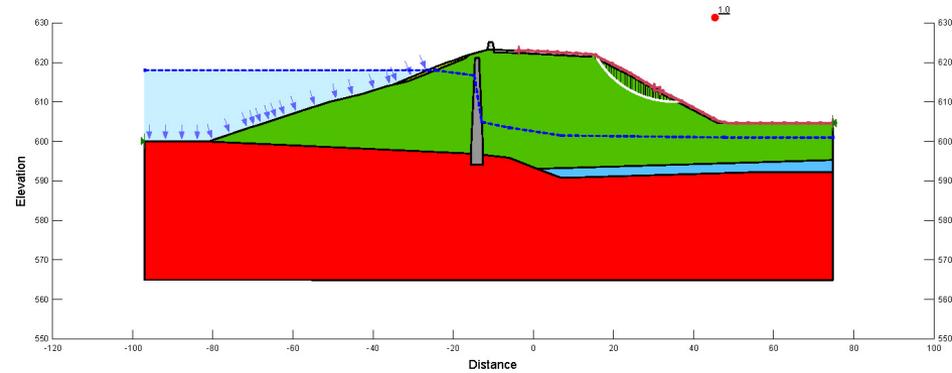
Lake Carmel Dam
 (4b) D/S Slope - Seismic Yield (EL 618)
 August 2022
 Created By: Zachary King, EIT
 Checked By: Matthew Palmer

Horz Seismic Coef.: 0.162

Color	Name	Unit Weight (pcf)	Effective Cohesion (psf)	Effective Friction Angle (°)	Cohesion R (psf)	Phi R (°)
Green	(1) Embankment Material	120	0	31	200	17
Blue	(2) Alluvial Foundation	125	0	35	0	0
Red	(3) Glacial Foundation	130	0	34	200	18
Yellow	(4) Rockfill	140	0	40	0	0
Grey	(5) Concrete Core Wall	150	5,000	0	0	0
Light Grey	(6) Road	150	2,500	0	0	0

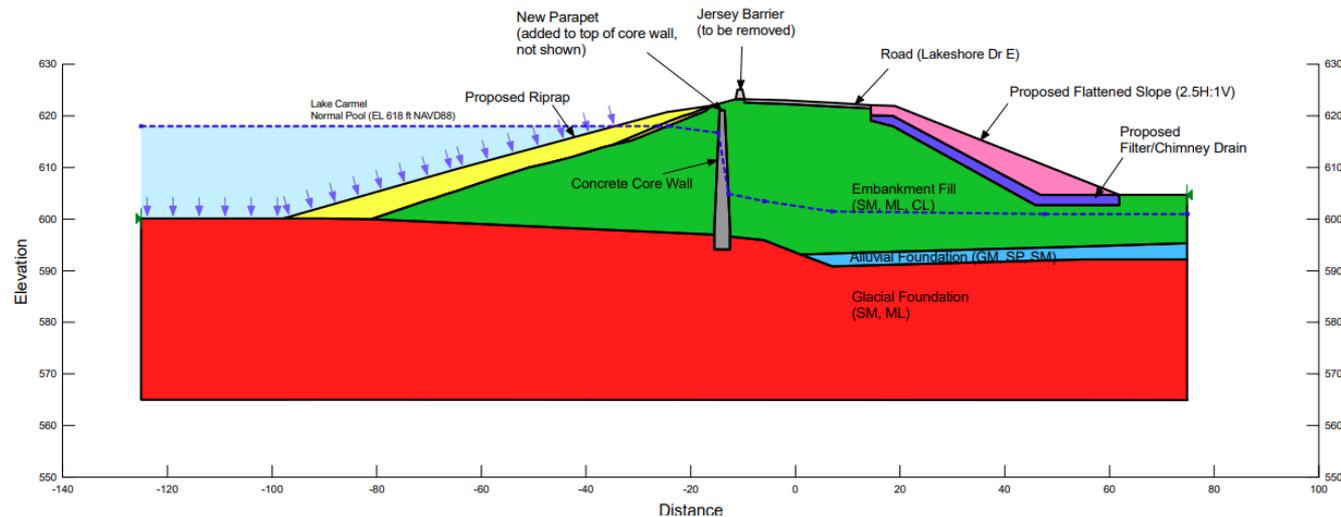
Lake Carmel Dam
(0) Conceptual Geometry
August 2022
Created By: Zachary King, EIT
Checked By: Luke Scillieri

Evaluation of modified embankment dam geometry:

- Flattened d/s slope with added internal filter
- Increased height for core wall
- Flattened u/s slope

Color	Name	Unit Weight (pcf)	Effective Cohesion (psf)	Effective Friction Angle (°)
Blue	(1) Drainage Material	120	0	33
Green	(1) Embankment Material	120	0	31
Pink	(1) Select Embankment Material	120	0	33
Light Blue	(2) Alluvial Foundation	125	0	35
Red	(3) Glacial Foundation	130	0	34
Yellow	(4) Rockfill	140	0	40
Grey	(5) Concrete Core Wall	150	5,000	0
Light Grey	(6) Road	150	2,500	0

Modified geometry and internal filter provide necessary increase in FS for all loading cases.

Modified geometry improves seismic performance (increase horizontal yield acceleration, H_y)
