Palmer Lake Restoration Plan Towns of Kent and Carmel Putnam County, NY

Princeton Hydro, LLC

December 2014

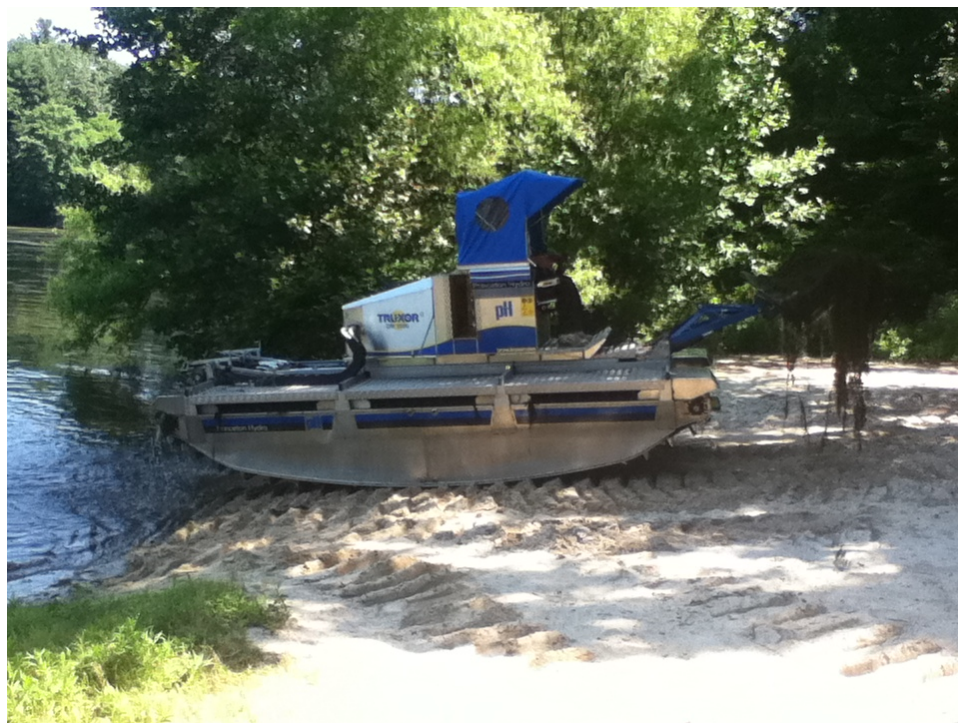
Figure 1: The Truxor, an amphibious aquatic harvesting machine

The Truxor can reach shallow areas that a conventional weed harvester cannot, from both water and land. It can harvest aquatic plants and algae in water as shallow as less than a foot and even harvest shoreline vegetation. The Truxor can also remove nuisance / invasive wetland species, leaf litter and woody debris and conduct some small-scale dredging but such activities would require permits. With the extendable arm, the Truxor can harvest at depths up to 6 feet deep, however, it is generally used to harvest aquatic vegetation from depths less than 3 feet, areas that are not readily accessible by conventional harvesting equipment. In addition, the machine is relatively easy to launch and deploy. Thus, the Truxor may be a particularly effective, non-chemical means of removing nuisance vegetation, particularly along the near-shore areas along the southern end of Palmer Lake.

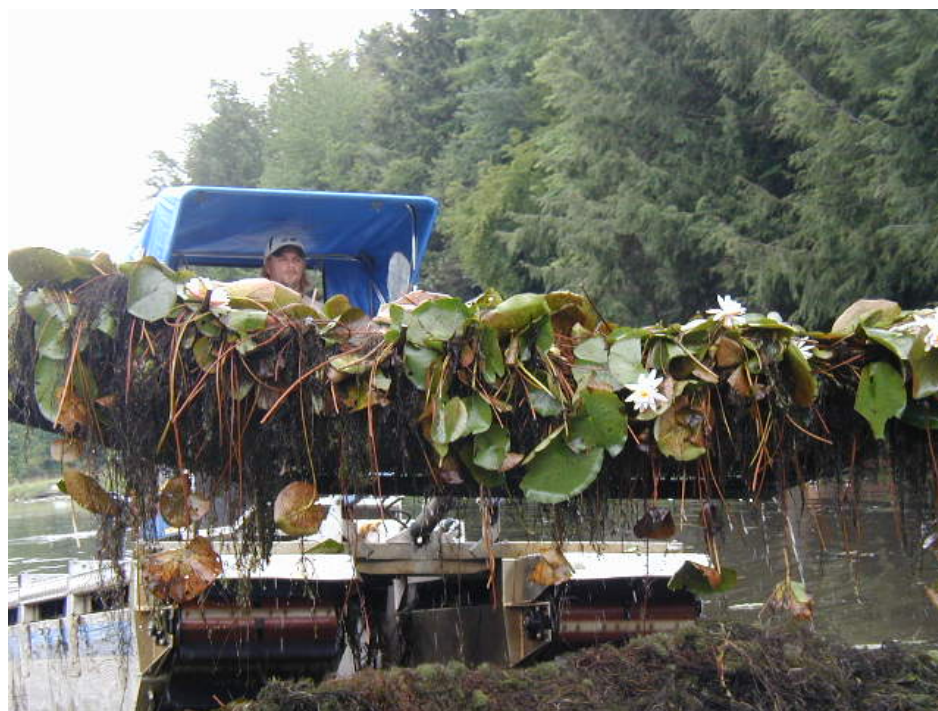
Figure 2: The Truxor in operation, harvesting water lilies and submerged vegetation

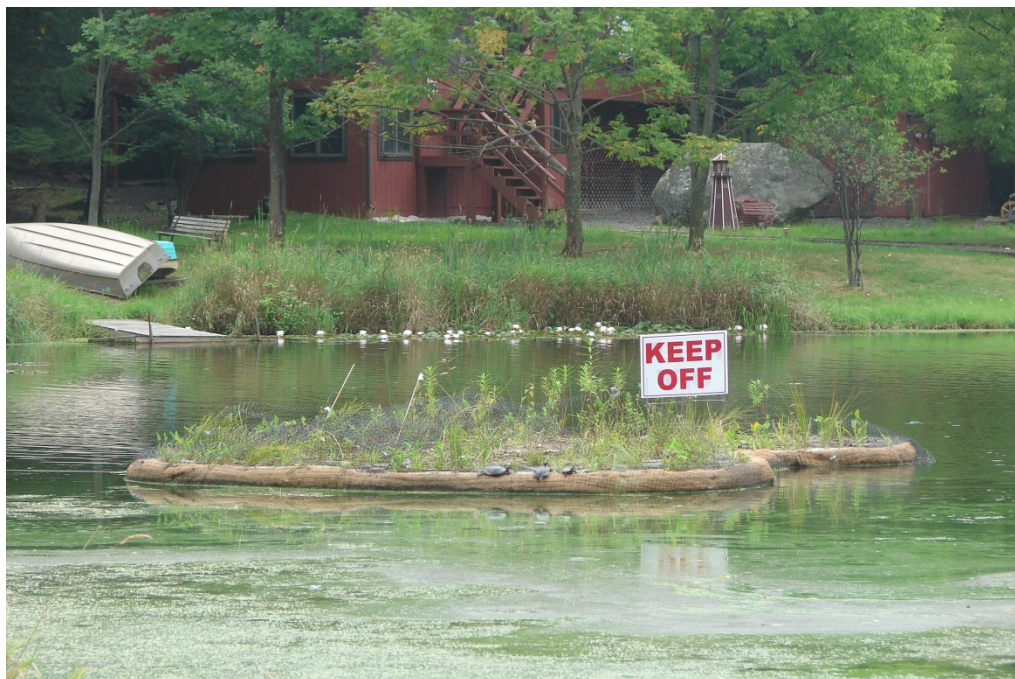
Figure 3: Floating Wetland Island built, deployed and anchored in a lake in Wayne County, PA in 2010

The FWIs are constructed and planted along the shoreline and then deployed to their targeted location with the aid of a boat (Figure 3). The Islands are anchored in waters approximately 3 to 10 feet in depth. We would recommend installing them toward the northern end of the lake where the main inlet enters the lake. This would provide a means of treating the incoming inflow and removing some of the available nutrients before entering the main body of the lake where it can stimulate nuisance algae (particularly blue-green algae also known as cyanobacteria) and aquatic plant growth.

Maintenance is relatively minimal for the FWIs. Goose netting needs to be installed and routinely inspected to ensure it is intact at least for the first year (Figure 3). Princeton Hydro has installed and monitored FWIs throughout Pennsylvania and New Jersey since 2010 and after the first year once the vegetation is well established water fowl such as Canada geese will leave the Islands alone. Additionally, the vegetation should be periodically inspected to ensure growth is healthy. Occasionally, after a particularly heavy storm the Islands need to be re-positioned. However, in general the maintenance associated with the FWIs is fairly low and they have an expected life of approximately 15 years (Figure 4).

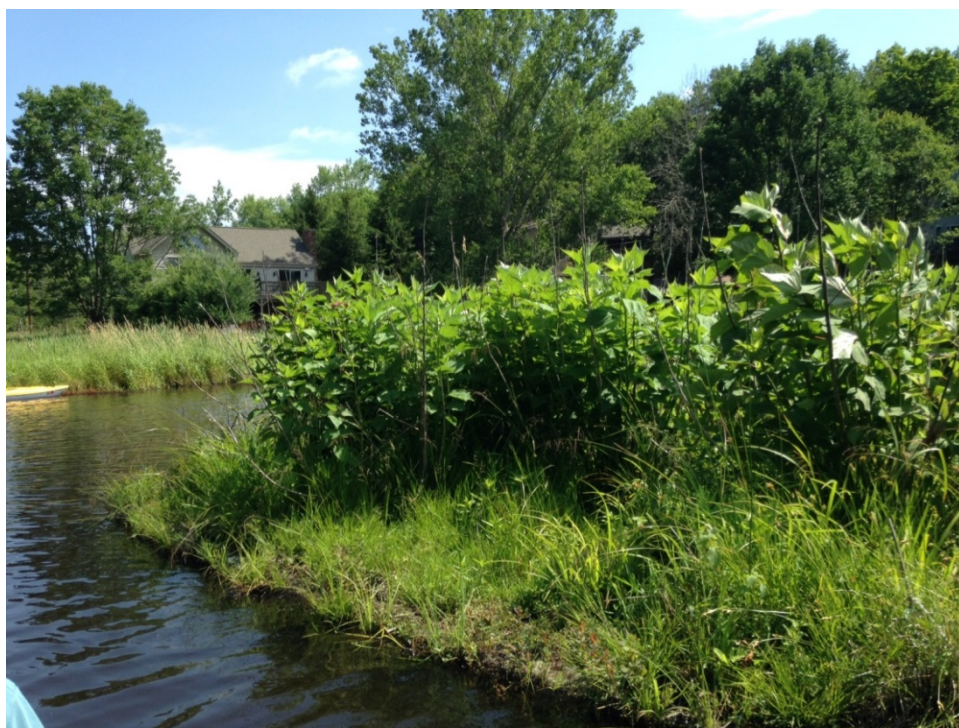
Figure 4: Established Floating Wetland Island in a lake in Wayne County, PA in 2014
