Town of Kent

Lake Carmel Park District Community Center Building Renovation Study Report

July 2023

Barton & Loguidice

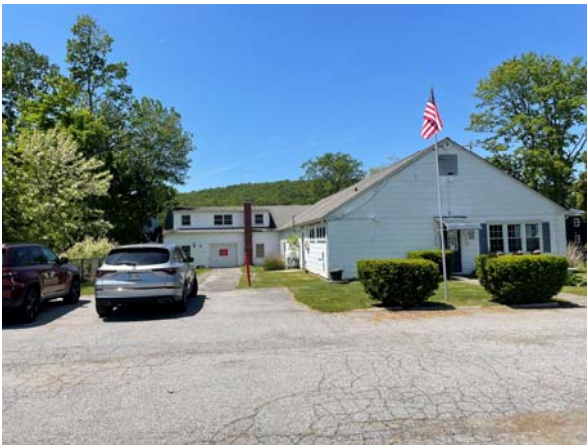
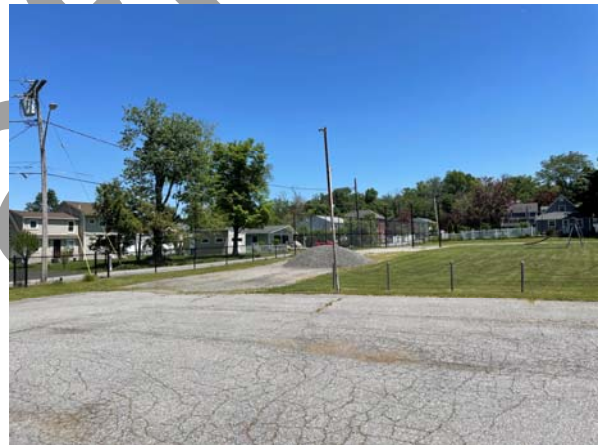
The existing facility is located at 10 Huguenot Road Carmel Hamlet, NY 10512 and is a 5,134 square foot building constructed in 1950 and consists of a basement/ground floor, first floor and garage with second story space. The building was constructed with masonry/concrete structure foundations, wood framed upper level exterior walls, wood framed window units, asphalt shingle roof system. There is a mix of replacement windows and various door types and materials throughout the facility. There is a mix of acoustical and gypsum ceilings throughout the building. The building is located on a 1.60 acre lot and includes existing paved parking areas, a basketball court, playground equipment and open recreational lawn area. The property contains an existing water well, existing sanitary leach field and holding tank, and is an L-shape parcel surrounded on two sides by public roads (Yorktown Road to the north and Huguenot Road to the south). The property is located in an existing residential neighborhood with houses all around the property and Lake Carmel is located a short distance to the east from the property. The property is fairly flat and has chain link and privacy fencing around most of the perimeter of the property. The existing building is located on the small section of the L-shaped parcel with residential houses adjacent to it on two sides.

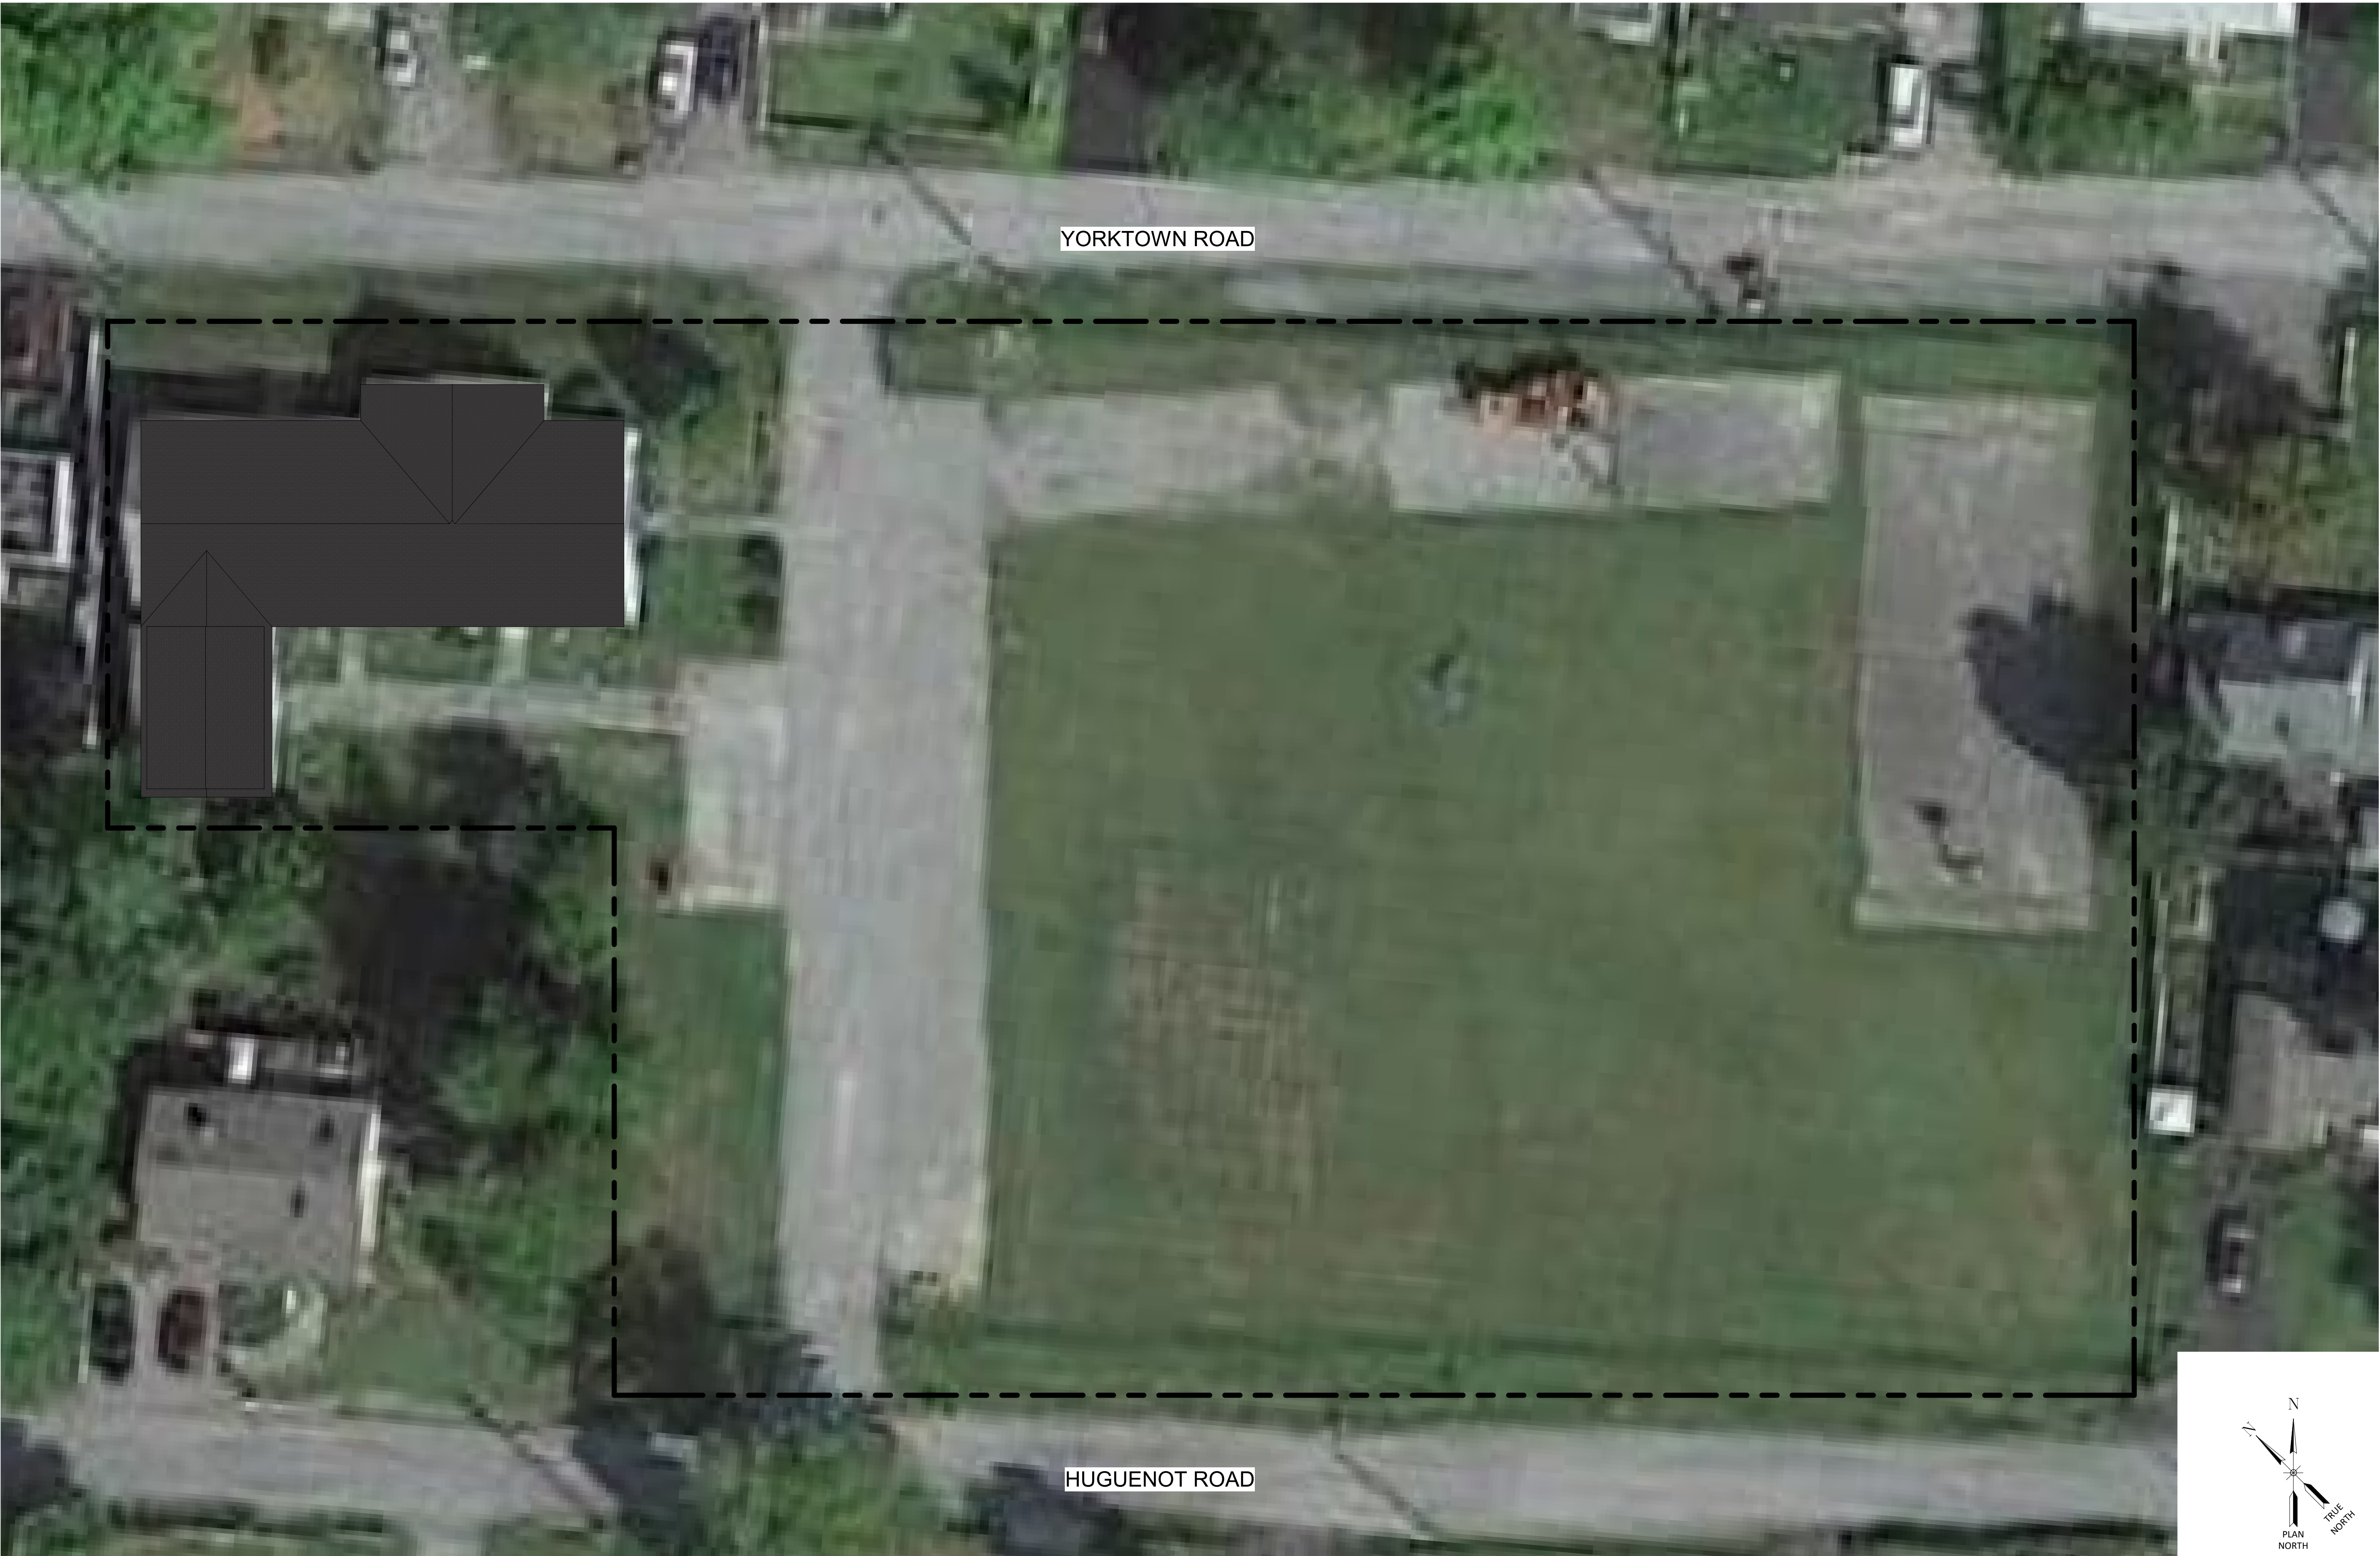
1
G101 EXISTING SITE PLAN
1/16" = 1'-0"

TOWN OF KENT
LAKE CARMEL PARK DISTRICT COMMUNITY CENTER BUILDING RENOVATION STUDY
EXISTING SITE AERIAL MAP
TOWN OF KENT

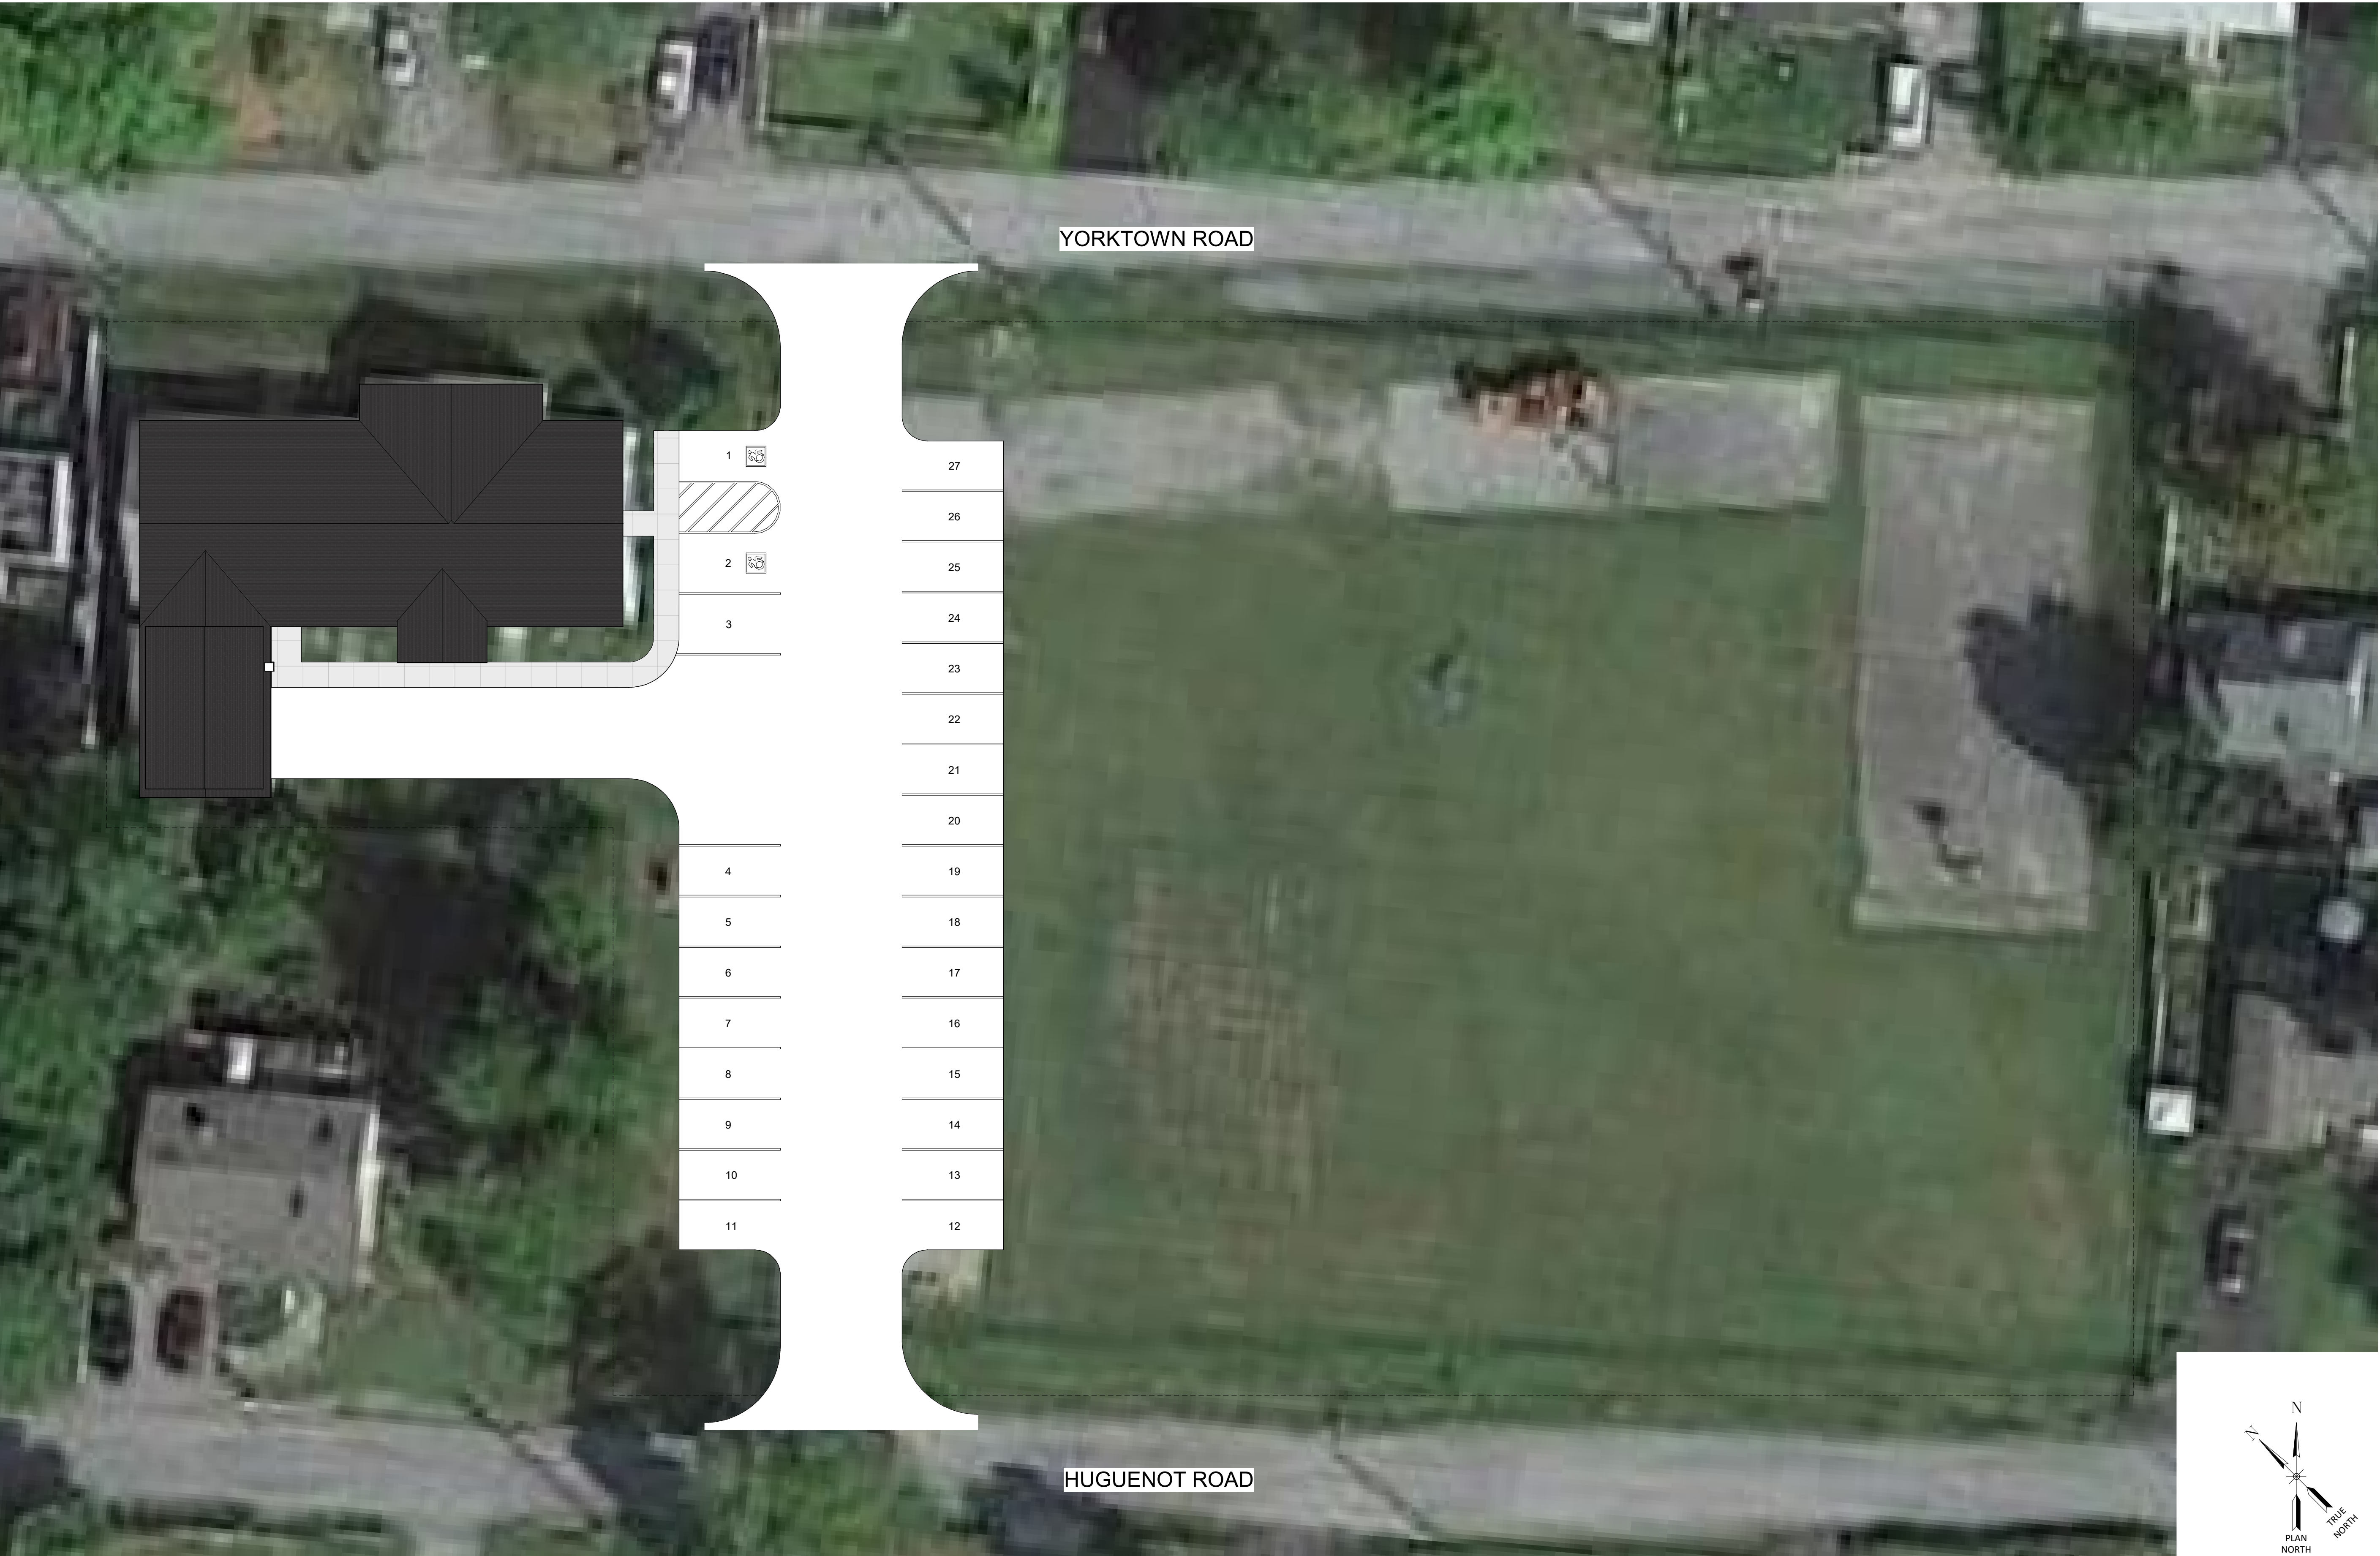
1
G102 NEW WORK SITE PLAN (OPTION A)
1/16" = 1'-0"

TOWN OF KENT
LAKE CARMEL PARK DISTRICT COMMUNITY CENTER BUILDING RENOVATION STUDY
NEW WORK SITE PLAN (OPTION A)
TOWN OF KENT

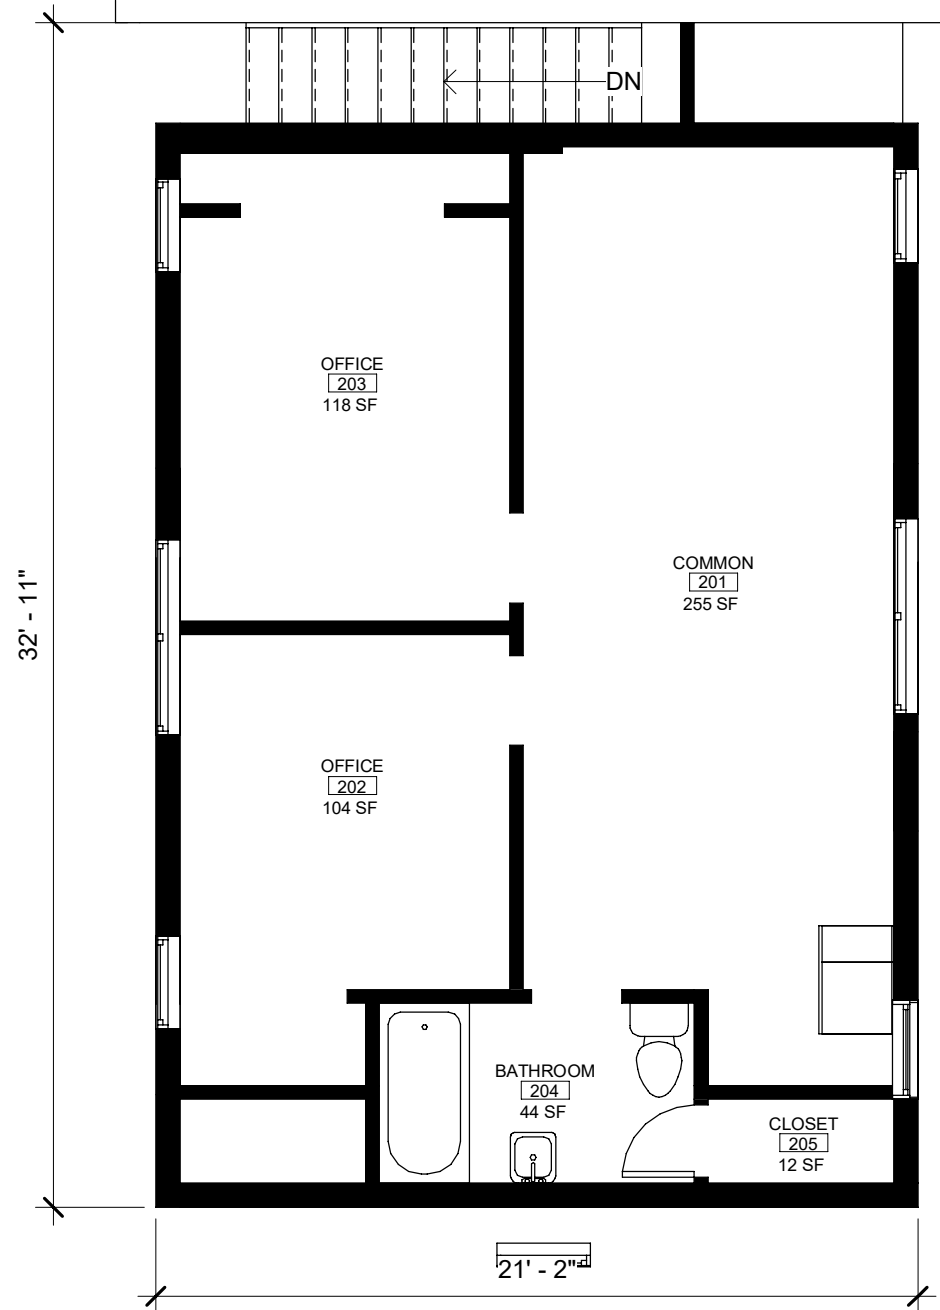
2
A101
EXISTING SECOND FLOOR PLAN
3/16" = 1'-0"

Existing Second Floor Plan

<u>Room No.</u>	<u>Room Name</u>	<u>Room Dimensions (+/-)</u>	<u>Area +/- (SF)</u>
201	Common	10'-3" x 26'-1"	255 SF
202	Office	13'-0" x 9'-2"	118 SF
203	Office	12'-6" x 9'-2"	104 SF
204	Bathroom	8'-8" x 5'-0"	44 SF
205	Closet	2'-4" x 5'-2"	12 SF
Existing Second Floor Plan Total			533 SF (Net)

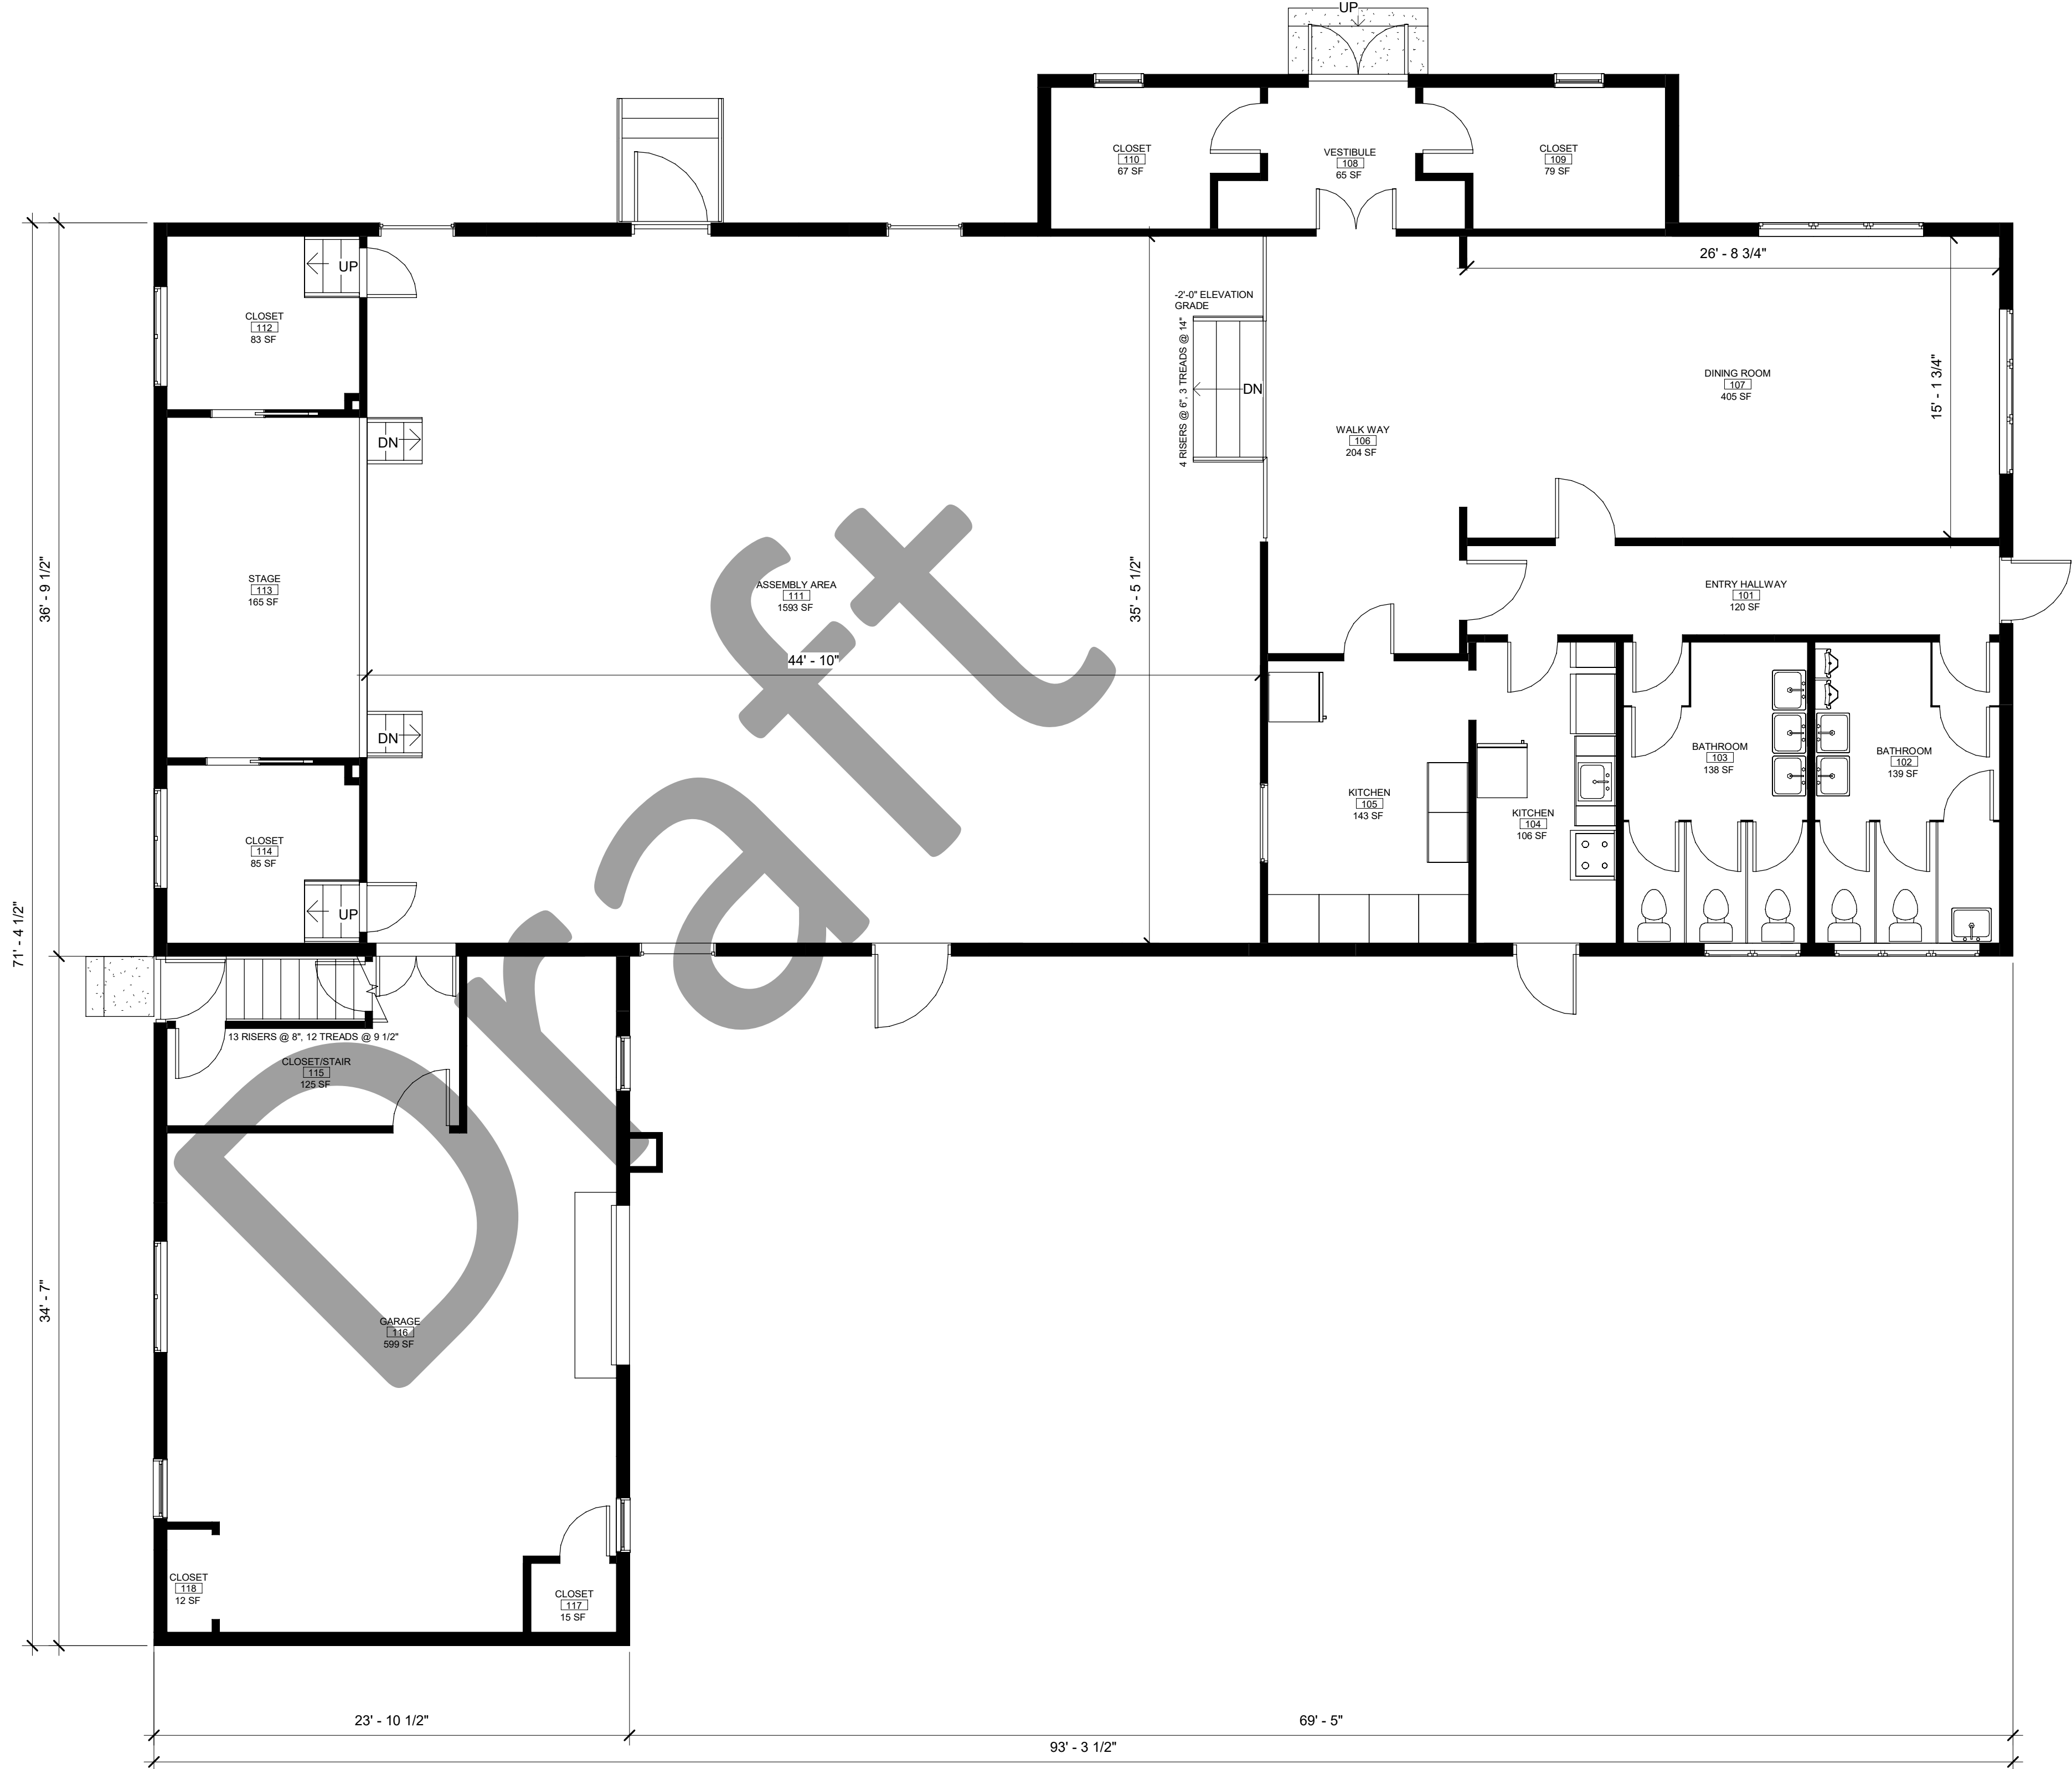
1
A101
EXISTING FIRST FLOOR PLAN
3/16" = 1'-0"

Existing First Floor Plan

<u>Room No.</u>	<u>Room Name</u>	<u>Room Dimensions (+/-)</u>	<u>Area +/- (SF)</u>
101	Entry Hallway	4'-6" x 27'-0"	120 SF
102	Bathroom	9'-3" x 15'-1"	139 SF
103	Bathroom	9'-2" x 15'-1"	139 SF
104	Machine Room	7'-0" x 15'-1"	106 SF
105	Kitchen	10'-1" x 14'-2"	143 SF
106	Walkway	20'-11" x 9'-7"	204 SF
107	Dining Room	15'-2" x 26'-9"	405 SF
108	Vestibule	7'-1" x 12'-5"	65 SF
109	Closet	7'-1" x 9'-8"	79 SF
110	Stair hall	7'-1" x 8'-0"	67 SF
111	Assembly Area	44'-10" x 35'-6"	1,593 SF
112	Closet	9'-8" x 8'-8"	83 SF
113	Stage	17'-1" x 9'-8"	165 SF
114	Closet	9'-8" x 8'-11"	85 SF
115	Closet/Stair	8'-6" x 14'-8"	125 SF
116	Garage	22'-6" x 25'-0"	599 SF
117	Closet	4'-3" x 3'-6"	15 SF
118	Closet	2'-3" x 5'-2"	12 SF
Existing First Floor Plan Total			4,144 SF (Net)

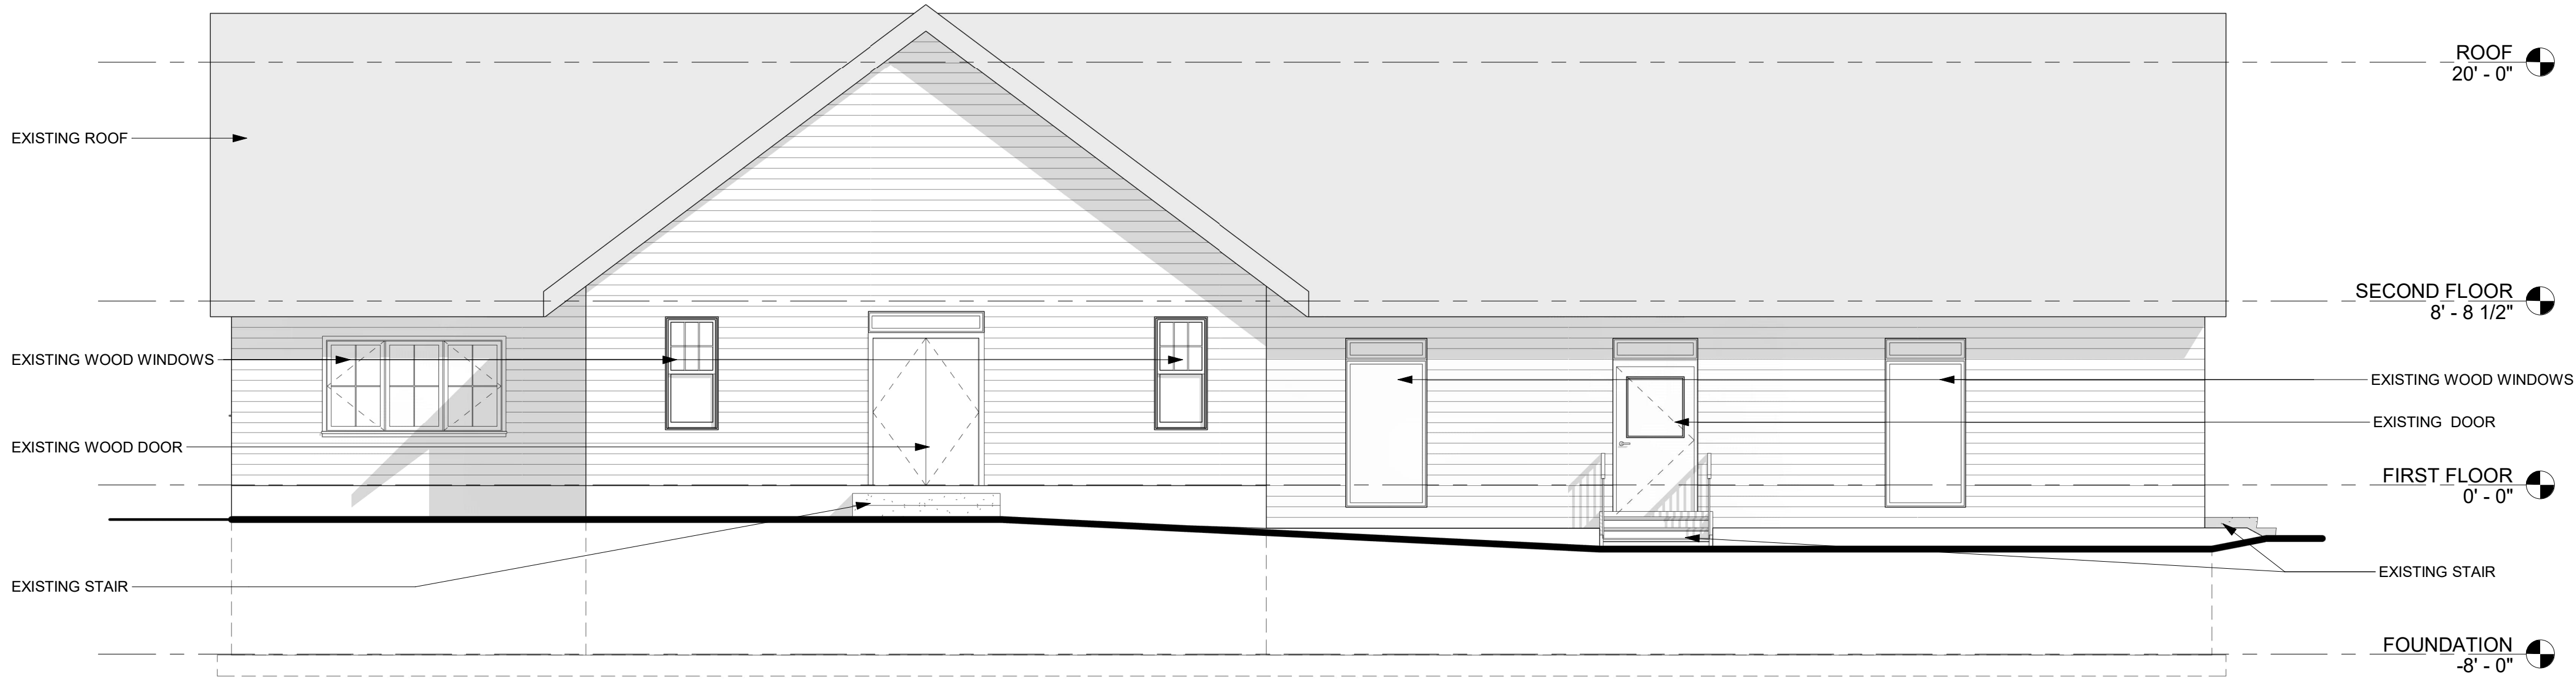
1
A102
EXISTING NORTH ELEVATION
3/16" = 1'-0"

EXISTING ELEVATIONS

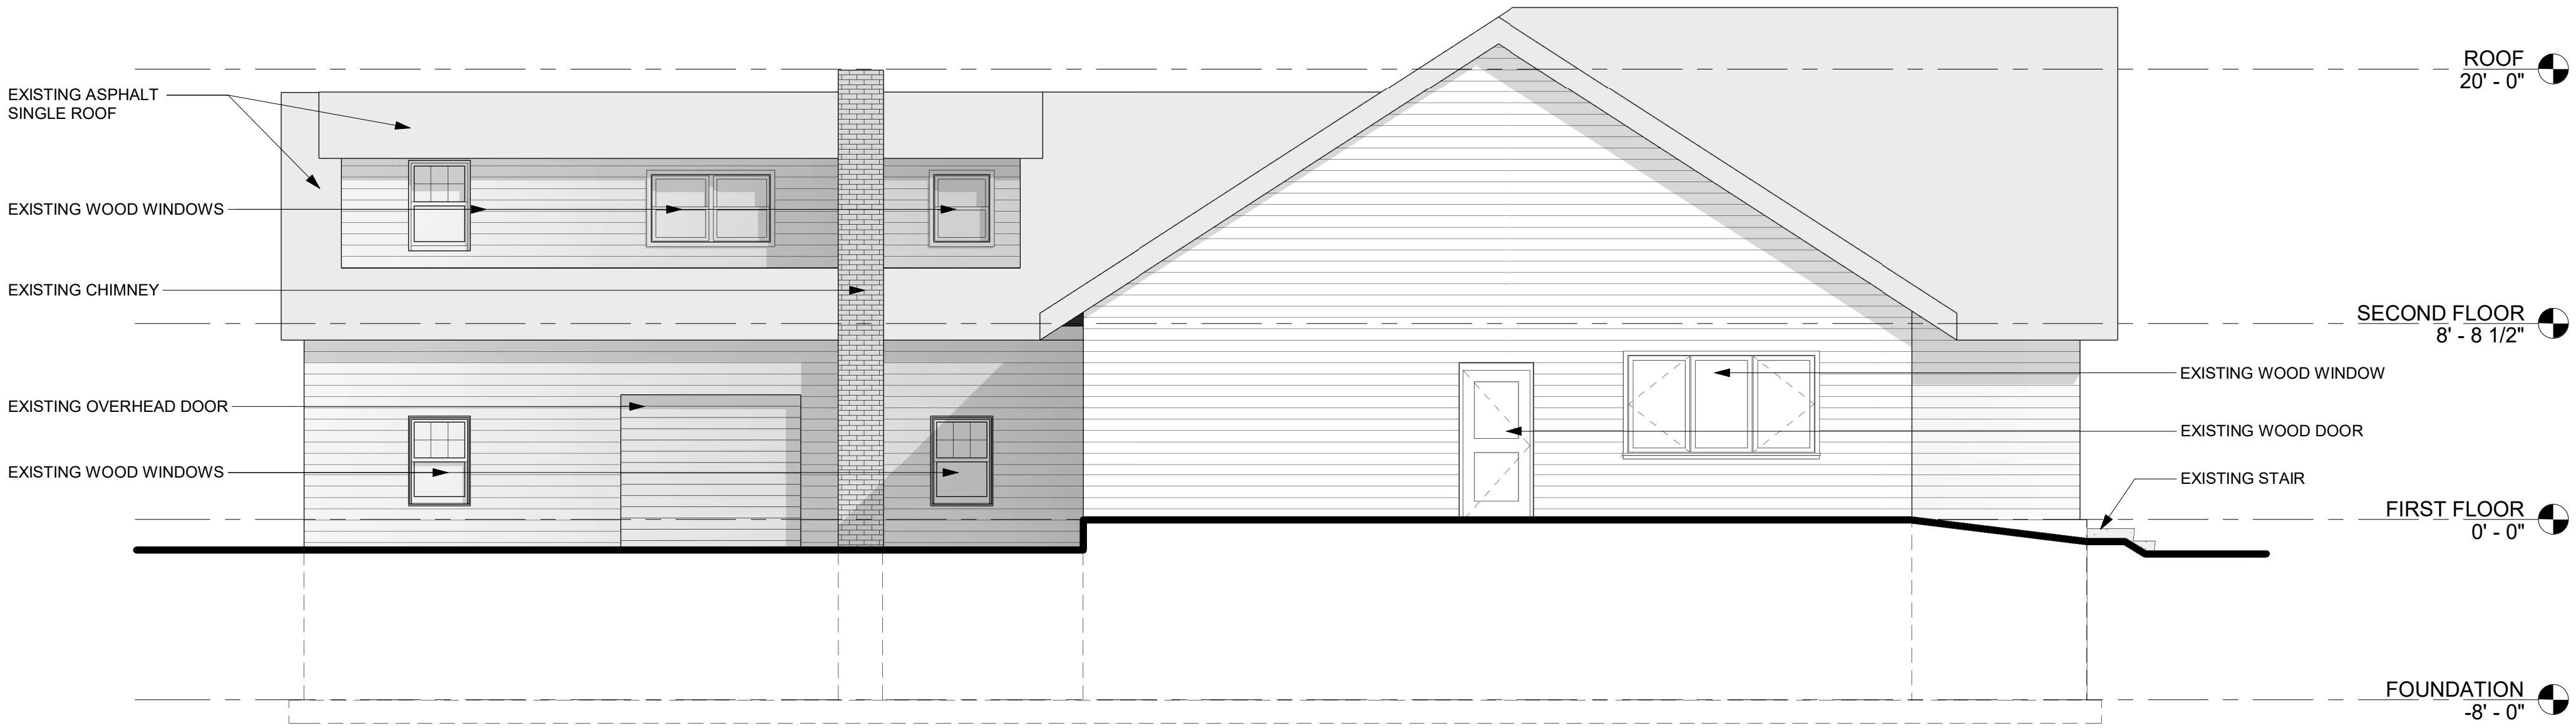
1 EXISTING EAST ELEVATION
A103 3/16" = 1'-0"

EXISTING ELEVATIONS

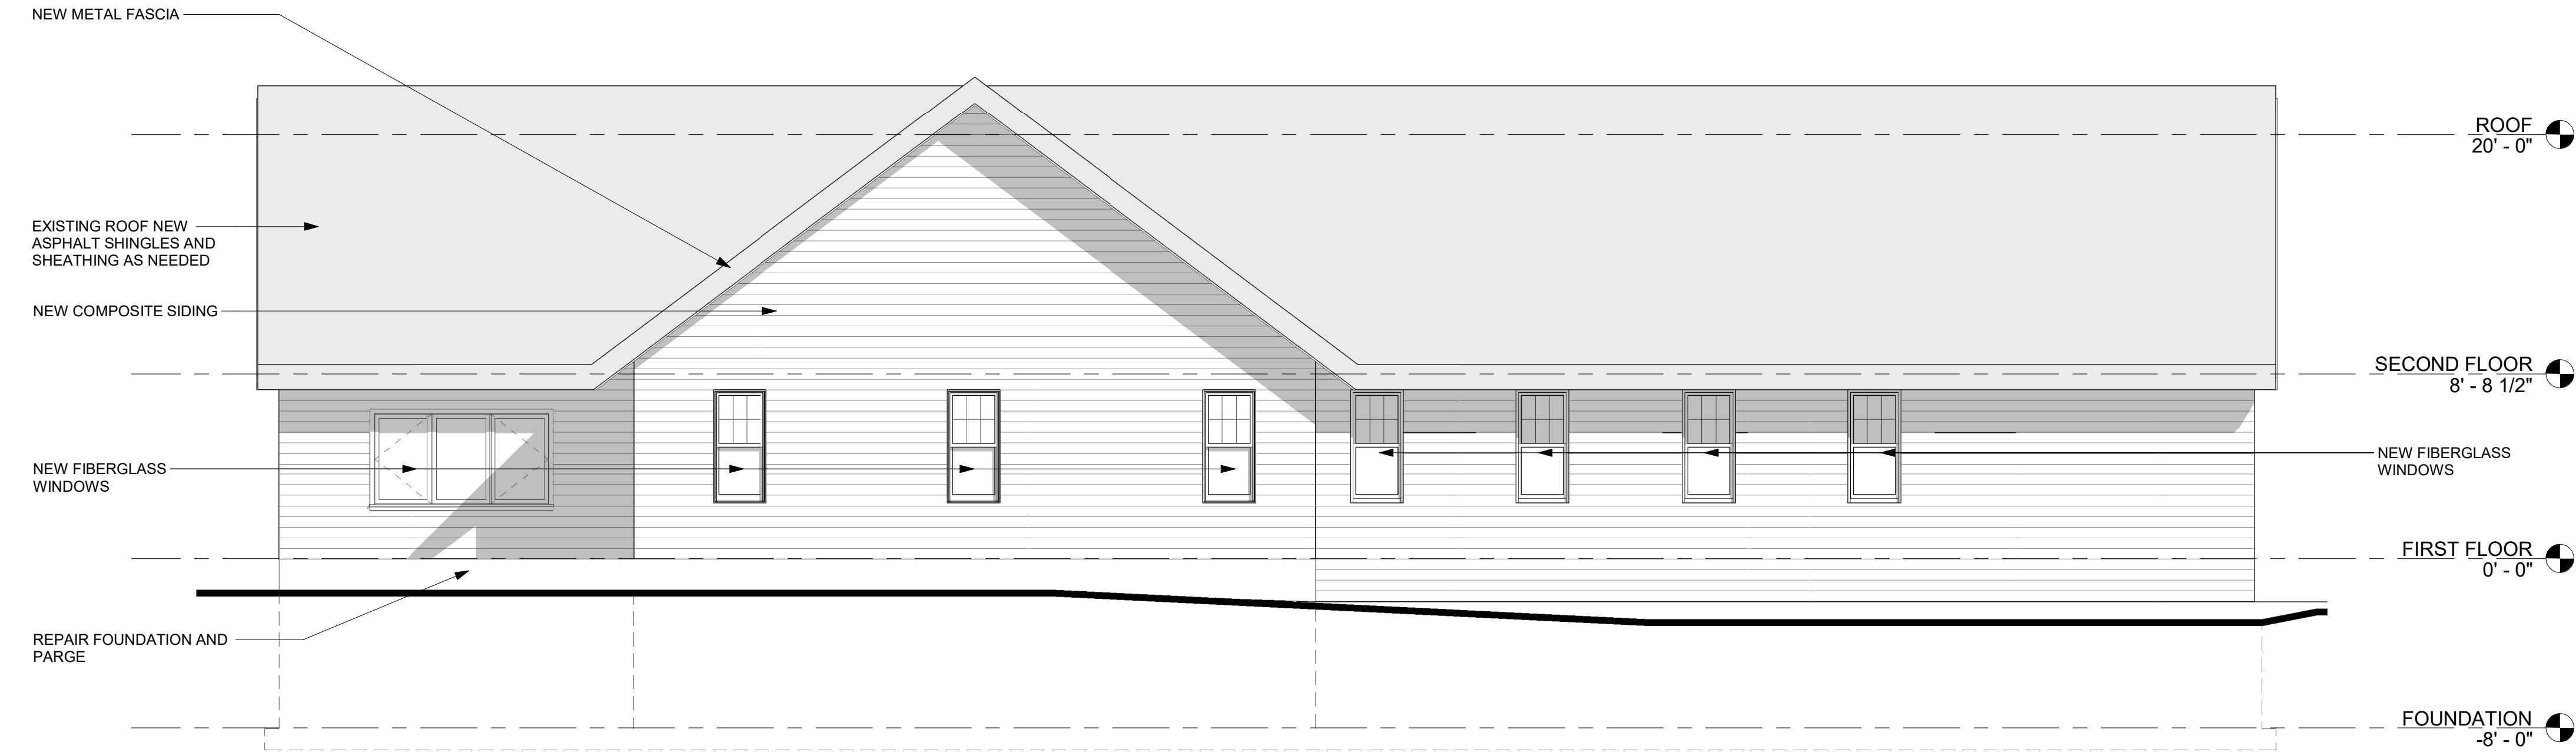
1
A105 NEW WORK NORTH ELEVATION
3/16" = 1'-0"

NEW WORK ELEVATIONS (OPTION A)
